ERDC/CHL TR-01-26

# **Impacts of Navigation Channel Maintenance Dredging on the Coastal Processes of Chatham, Massachusetts**

Donald K. Stauble

September 2001

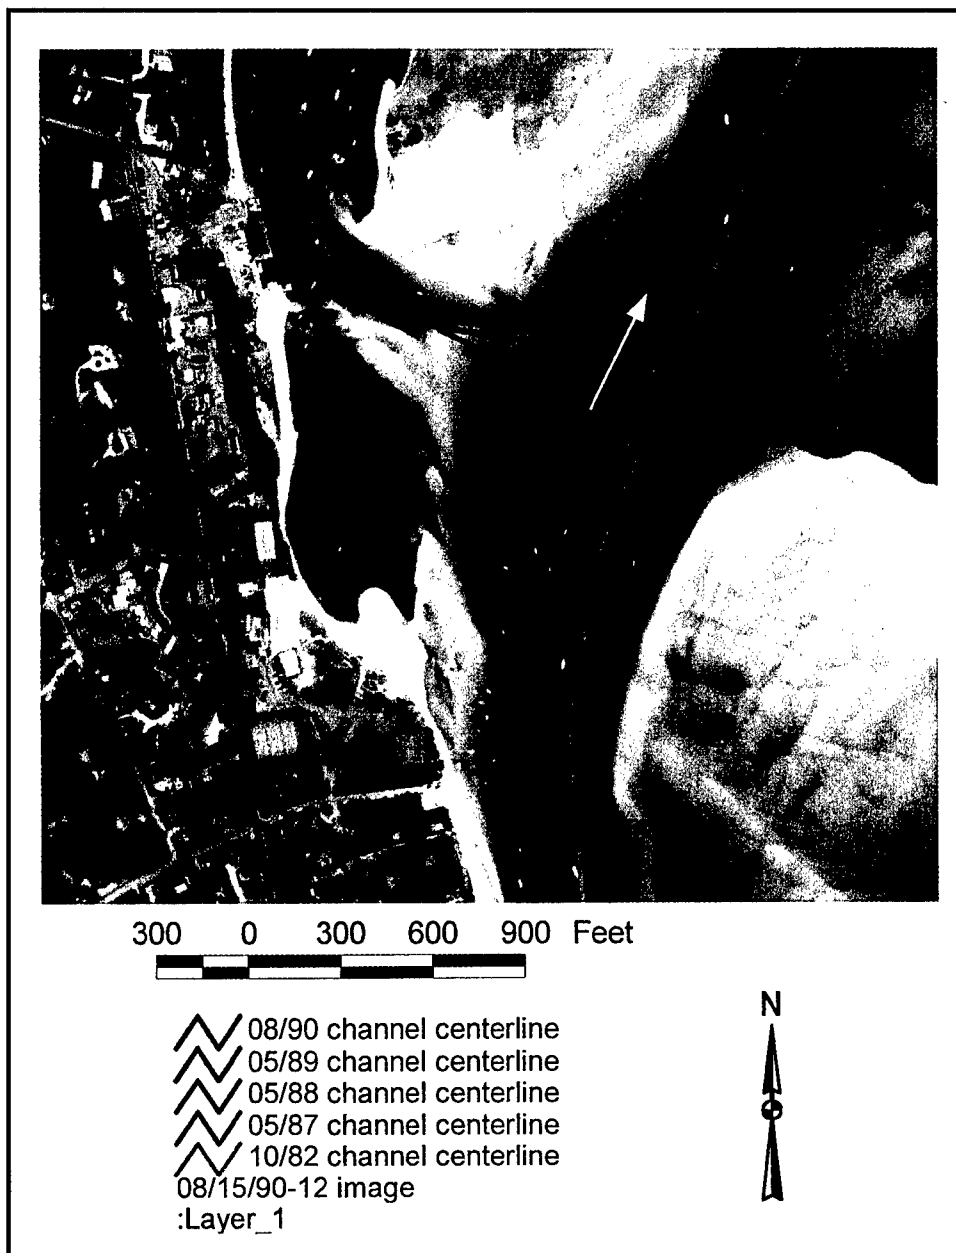
Figure 58. Evolution of Aunt Lydia's Cove entrance channel 1982-1990

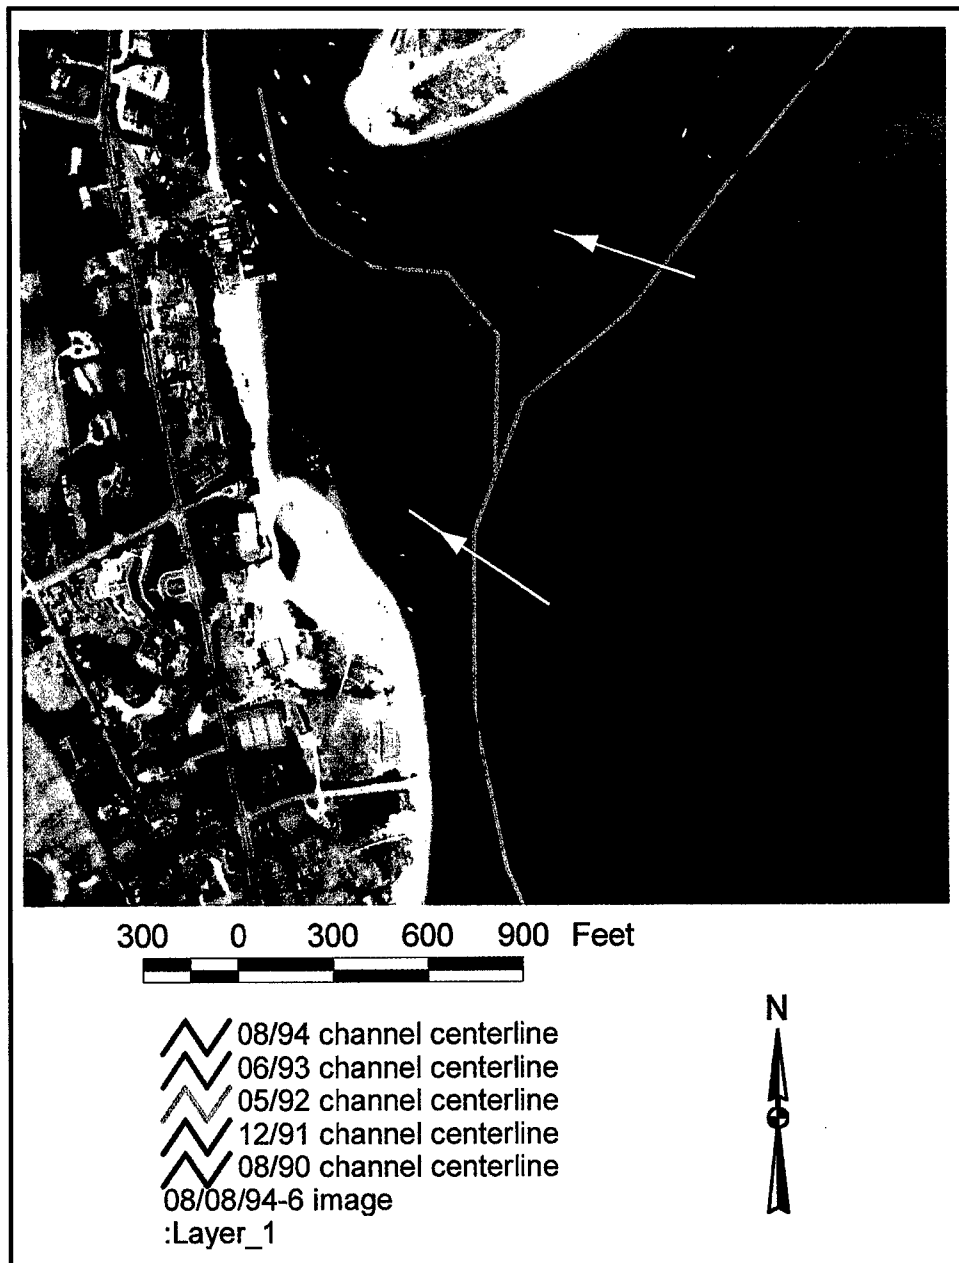
Figure 59. Evolution of Aunt Lydia's Cove entrance channel 1990-1994

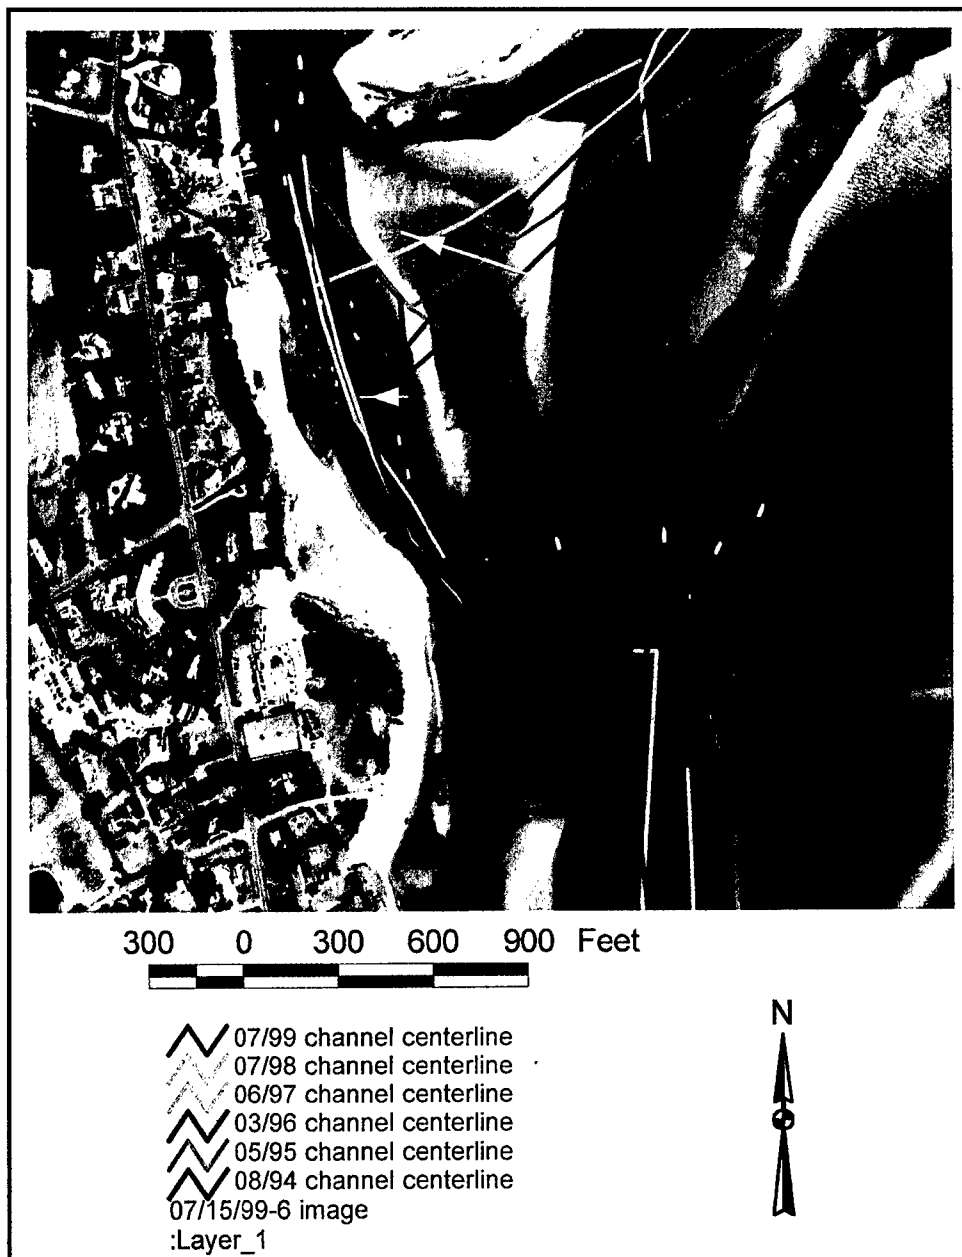
Figure 60. Evolution of Aunt Lydia's Cove entrance channel 1994-1999
